Unusual hardening of 100Cr6 steel in a defective ceramic hybrid roller bearing

Sigrid Binkowski and Mathias Woydt
Bundesanstalt für Materialforschung und -prüfung (BAM),
12200 Berlin, Germany

Struers   Journal
of Materialography
8/2005

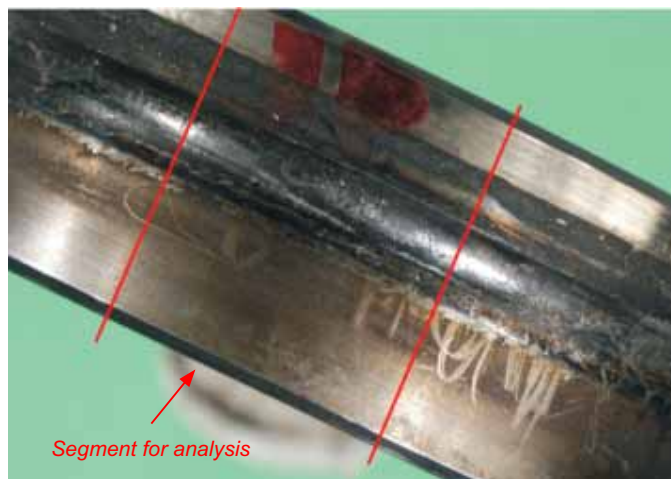
Fig. 1:
Location of segment removed for analysis

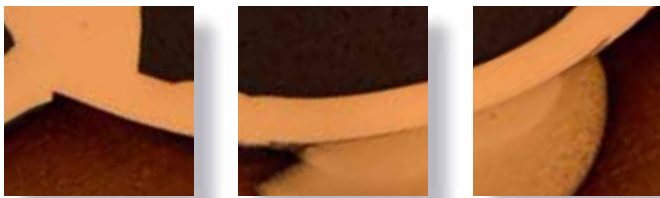
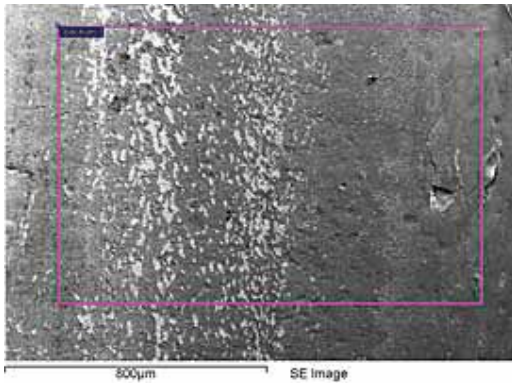
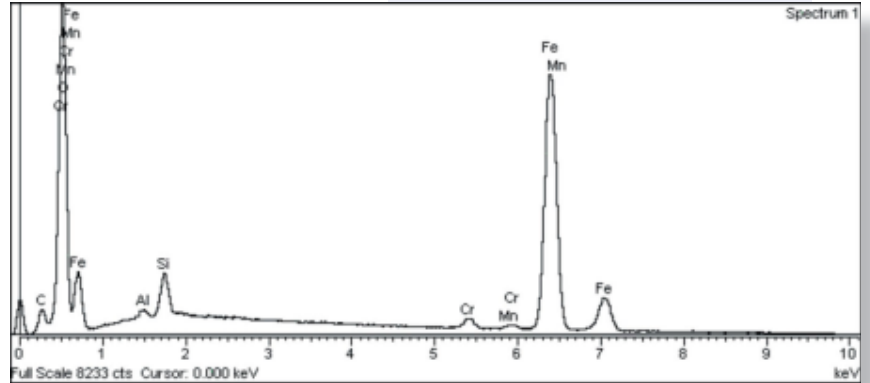
Fig. 2: Secondary electron image and element distribution map of the raceway of the bearing inner ring

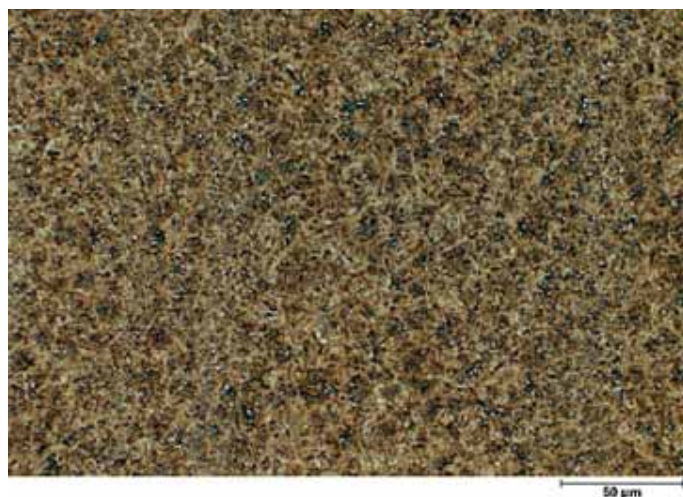
The microstructure of the bearing inner ring comprises finely acicular martensite with carbides that are in part linearly arrayed (fig. 4). The Vickers hardness number was measured to be 740 HV 0.2.

Fig. 4: Microstructure of the undamaged region comprising fine acicular martensite with carbides. (Vickers hardness: 740 HV; etchant: Nital)

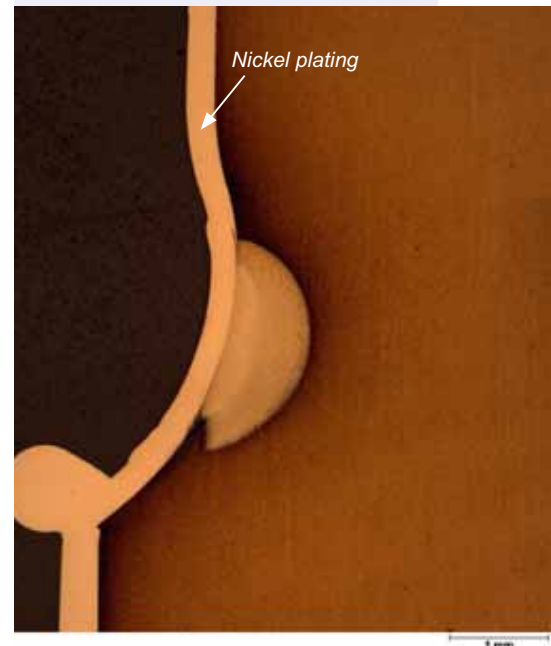
After final polishing, the specimen was etched with Nital (fig. 3). After five seconds, the damaged area was only weakly etched and etching had to be repeated. After renewed etching, the other part of the specimen was overetched.

Fig. 3: Cross-section of the bearing's inner ring: low-magnification optical microscopy image of the damaged region (etchant: Nital)

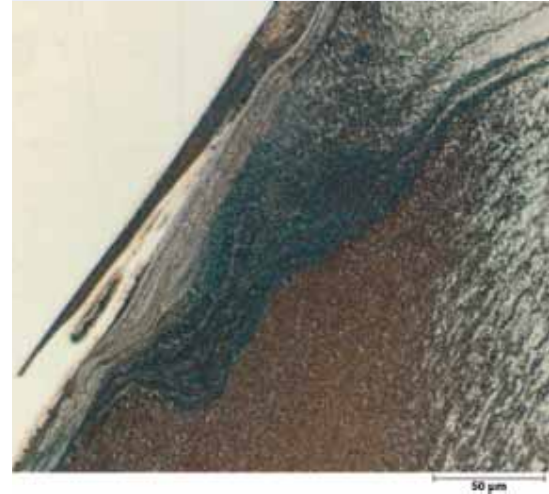
The lower damaged part of the raceway with its strongly deformed microstructure and the plated deposits from an aluminium alloy can be seen in figure 5.

Fig. 5: Image of the lower part of the damaged region (etchant: Nital)

In the case analysed here, chippings of aluminium alloys had penetrated the bearing raceway and were 'plated' or 'rolled' onto the surface causing a significant increase in frictional energy dissipation within the bearing. The very sudden failure of the bearing could not have been prevented by the monitoring sensor system.

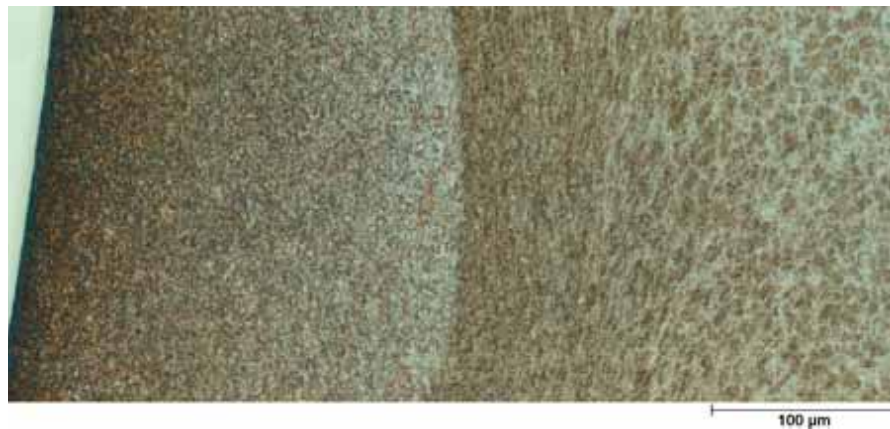
Fig. 7: Detailed image of the damaged region (etchant: iron(III)-chloride)

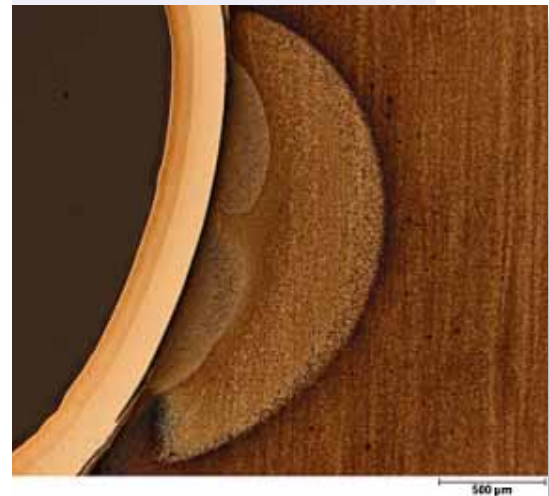
Fig. 6: Low-magnification optical microscopy image of the damaged region (etchant: iron(III)-chloride)

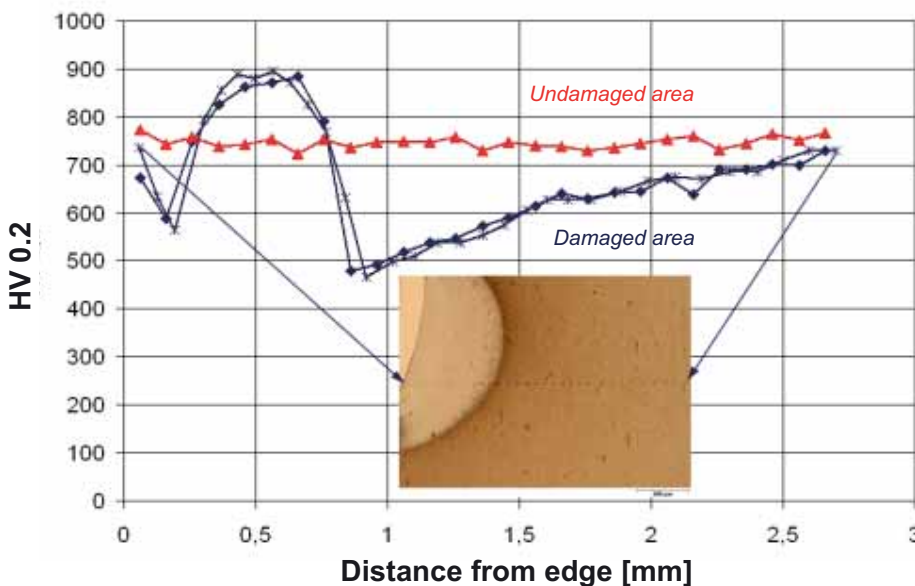
Hardness measurements were conducted on both the damaged and undamaged regions of the surface (fig. 8). The hardness-depth profile in the damaged area shows an initial fall in hardness to below 600 HV followed by an increase in hardness reaching almost 900 HV at a depth of 0.5 mm. Below 0.5 mm, the hardness decreases to below 500 HV (0.9 mm) and then rises again slowly eventually attaining the hardness values of the undamaged region at a depth of 2.7 mm. In contrast, the depth-hardness profile of the undamaged region showed a uniform hardness of 747 ± 12 HV 0.2.

Fig. 8: Hardness profile of the undamaged and damaged regions
